Chapter 4.9 | The Blowout Preventer

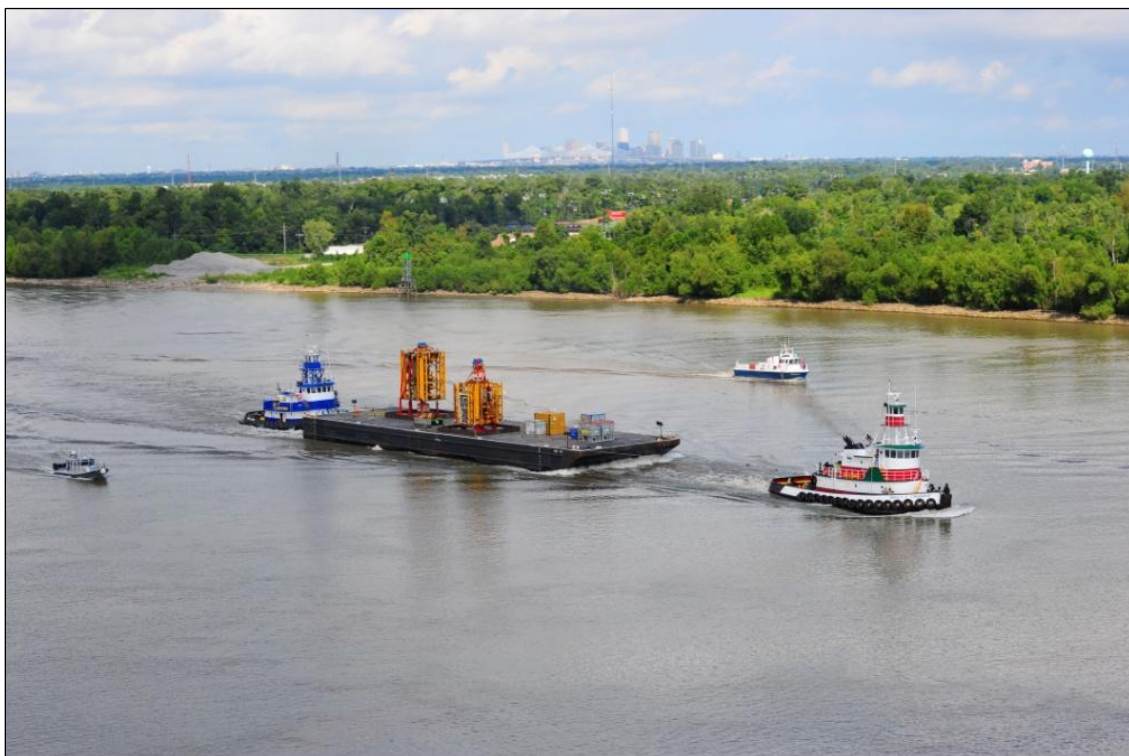
Figure 4.9.1. Transporting the *Deepwater Horizon* BOP.

The *Deepwater Horizon*'s blowout preventer on the Mississippi River in transit to Michoud, Louisiana, to undergo forensic testing, September 11, 2010.

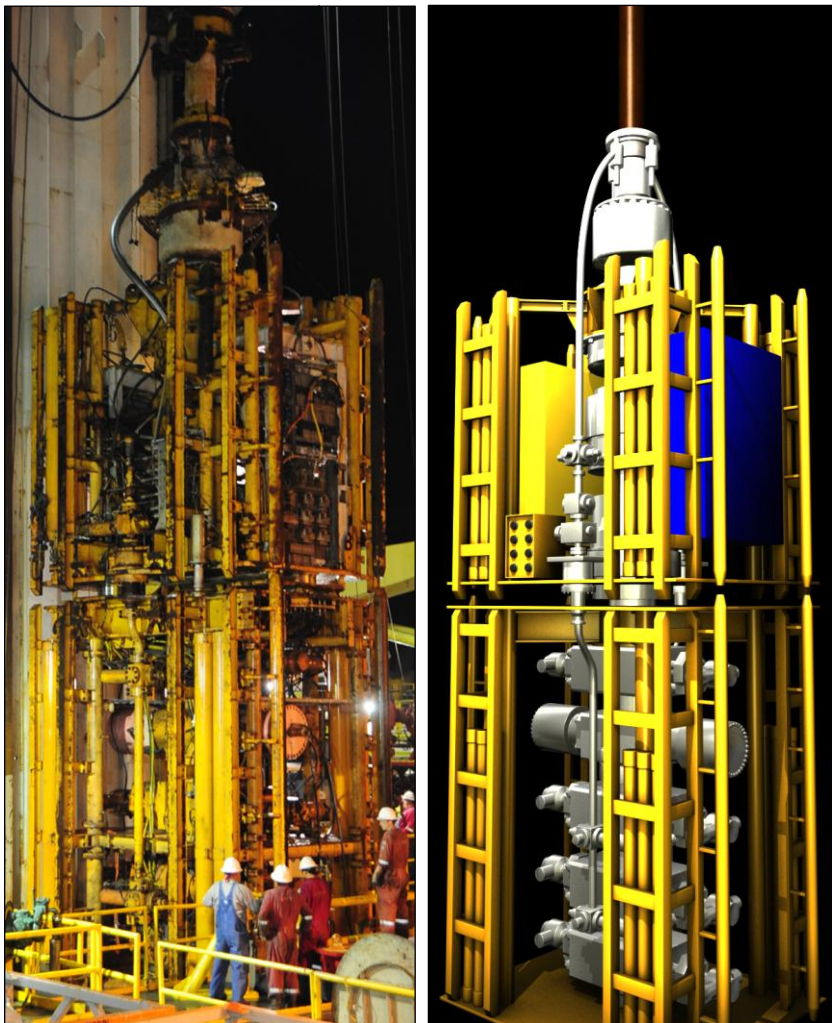
Figures 4.9.2 and 4.9.3. The *Deepwater Horizon* blowout preventer stack.

Left: Photo of the recovered *Deepwater Horizon* BOP.
Right: 3-D model of the *Deepwater Horizon* BOP.

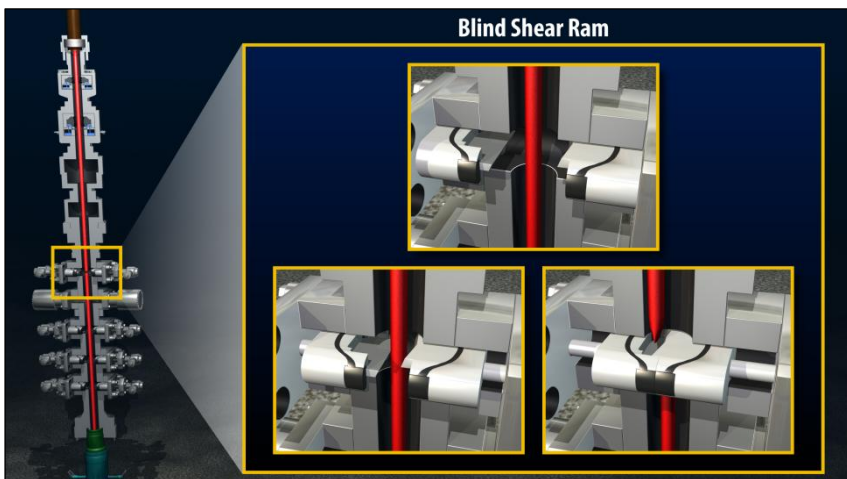
Figure 4.9.4. Blind shear ram.

Federal regulations required the *Deepwater Horizon* to have a BOP that included a **blind shear ram** (BSR).¹ The blind shear ram is designed to cut drill pipe in the well (as shown in Figure 4.9.4) and shut in the well in an emergency well control situation.* But even if properly activated, the blind shear ram may fail to seal the well because of known mechanical and design limitations. In order for a blind shear ram to shut in a well where drill pipe is across the BOP, it must be capable of shearing the drill pipe.² And blind shear rams are not always able to perform this critical function, even in controlled situations.

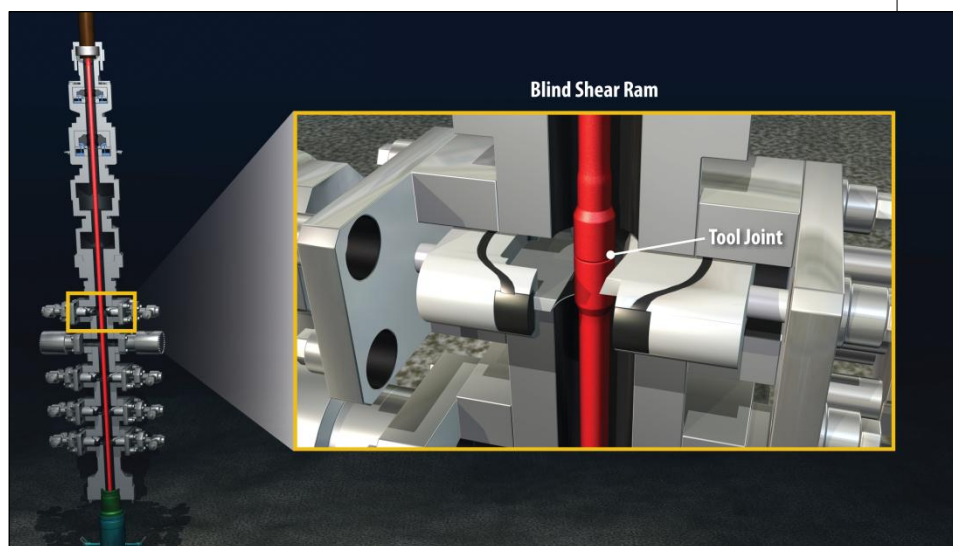
Figure 4.9.5. Tool joint in the blind shear ram.

The *Horizon's* blowout preventer had only one blind shear ram. Sections of drill pipe are joined by a tool joint at each interval and are often about 30 feet in length, though some of the drill pipe used on the *Horizon* varied in length.⁶ If one of those joints was in the path of the blind shear ram at the time of attempted activation, as portrayed in Figure 4.9.5, the ram would have been unable to shear the pipe and shut in the well.

Blind shear rams cannot cut tool joints.

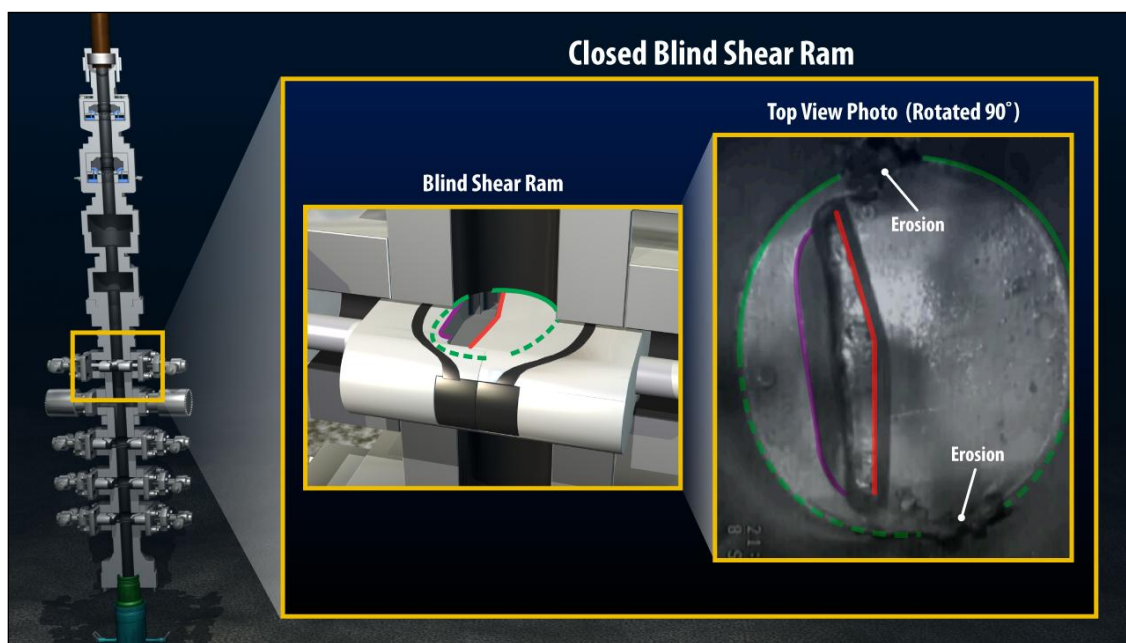
Figure 4.9.6. Deepwater Horizon blowout preventer's closed blind shear ram (top view).

Preliminary information from the recovered blowout preventer suggests the blind shear ram may have been closed and indicates erosion in the BOP on either side of the ram as pictured in Figure 4.9.6.³⁵ This suggests one of these mechanisms may have successfully activated the blind shear ram but failed to seal the flowing well because high-pressure hydrocarbons may have simply flowed around the closed ram.

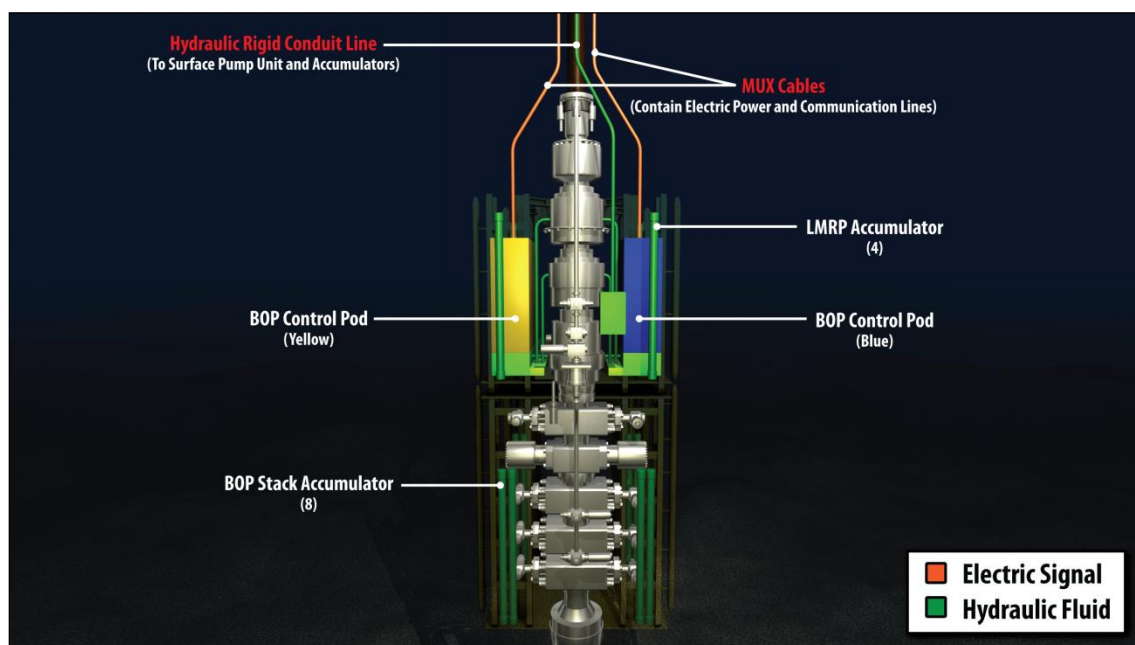
Figure 4.9.7. AMF system.

The AMF, or deadman, system is activated in emergency conditions.

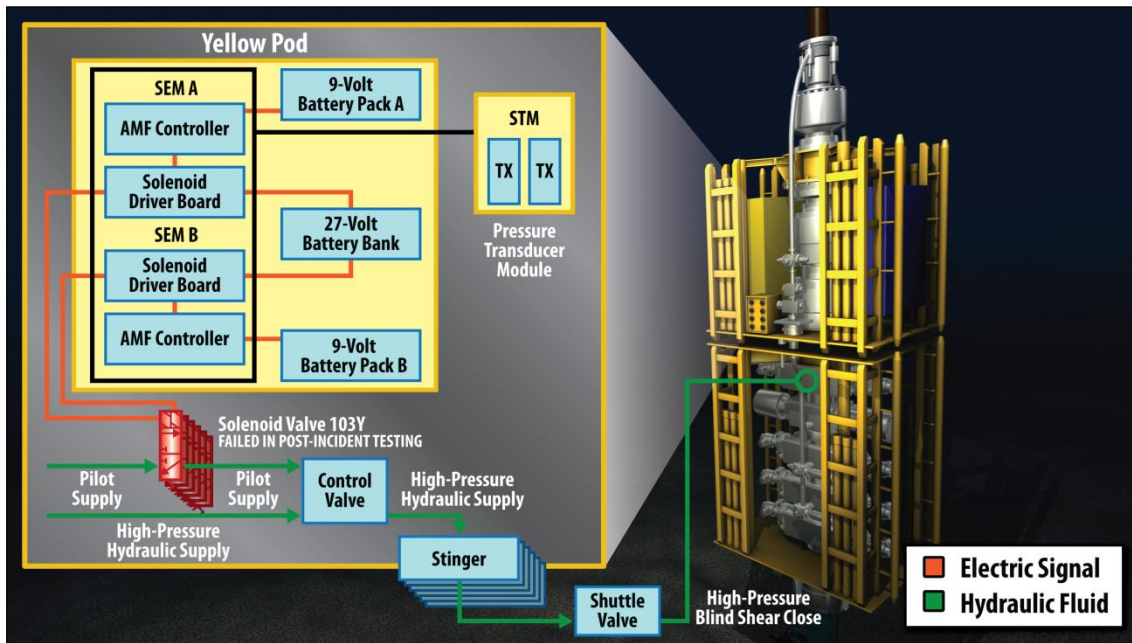
Figure 4.9.8. BOP’s electrical schematic.

Tests on the *Deepwater Horizon*’s yellow pod revealed that the solenoid valve used to close the blind shear ram was inoperable.

According to maintenance records, the yellow pod’s solenoids were changed on January 31, 2010.⁹² However, tests on the yellow pod conducted by Cameron after the blowout on May 5 to 7⁹³ revealed that a key solenoid valve used to close the blind shear ram was inoperable.⁹⁴

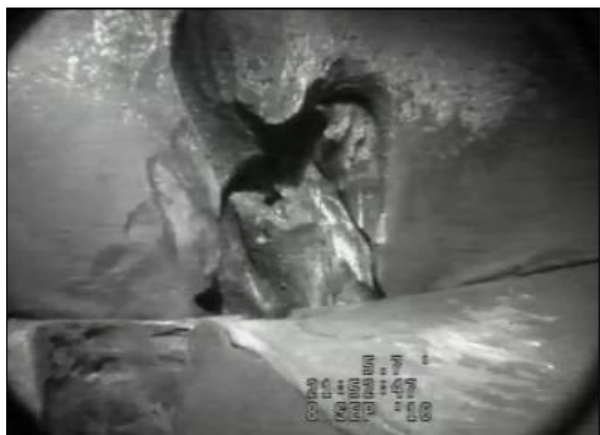
Figure 4.9.9. Erosion in the BOP.

Erosion above the blind shear ram on the BOP's kill side.

Even if the blind shear ram activated, it failed to seal the well. One possible explanation is that the high flow rate of hydrocarbons may have prevented the ram from sealing. Initial photos from the recovered BOP show erosion in the side of the blowout preventer *around* the ram, which was a possible flow path for hydrocarbons, as seen in Figure 4.9.9.¹⁰³ Therefore even if the ram closed, the hydrocarbons may have simply flowed around the closed ram.
