Chapter 4.3 | Cement

Well Cementing

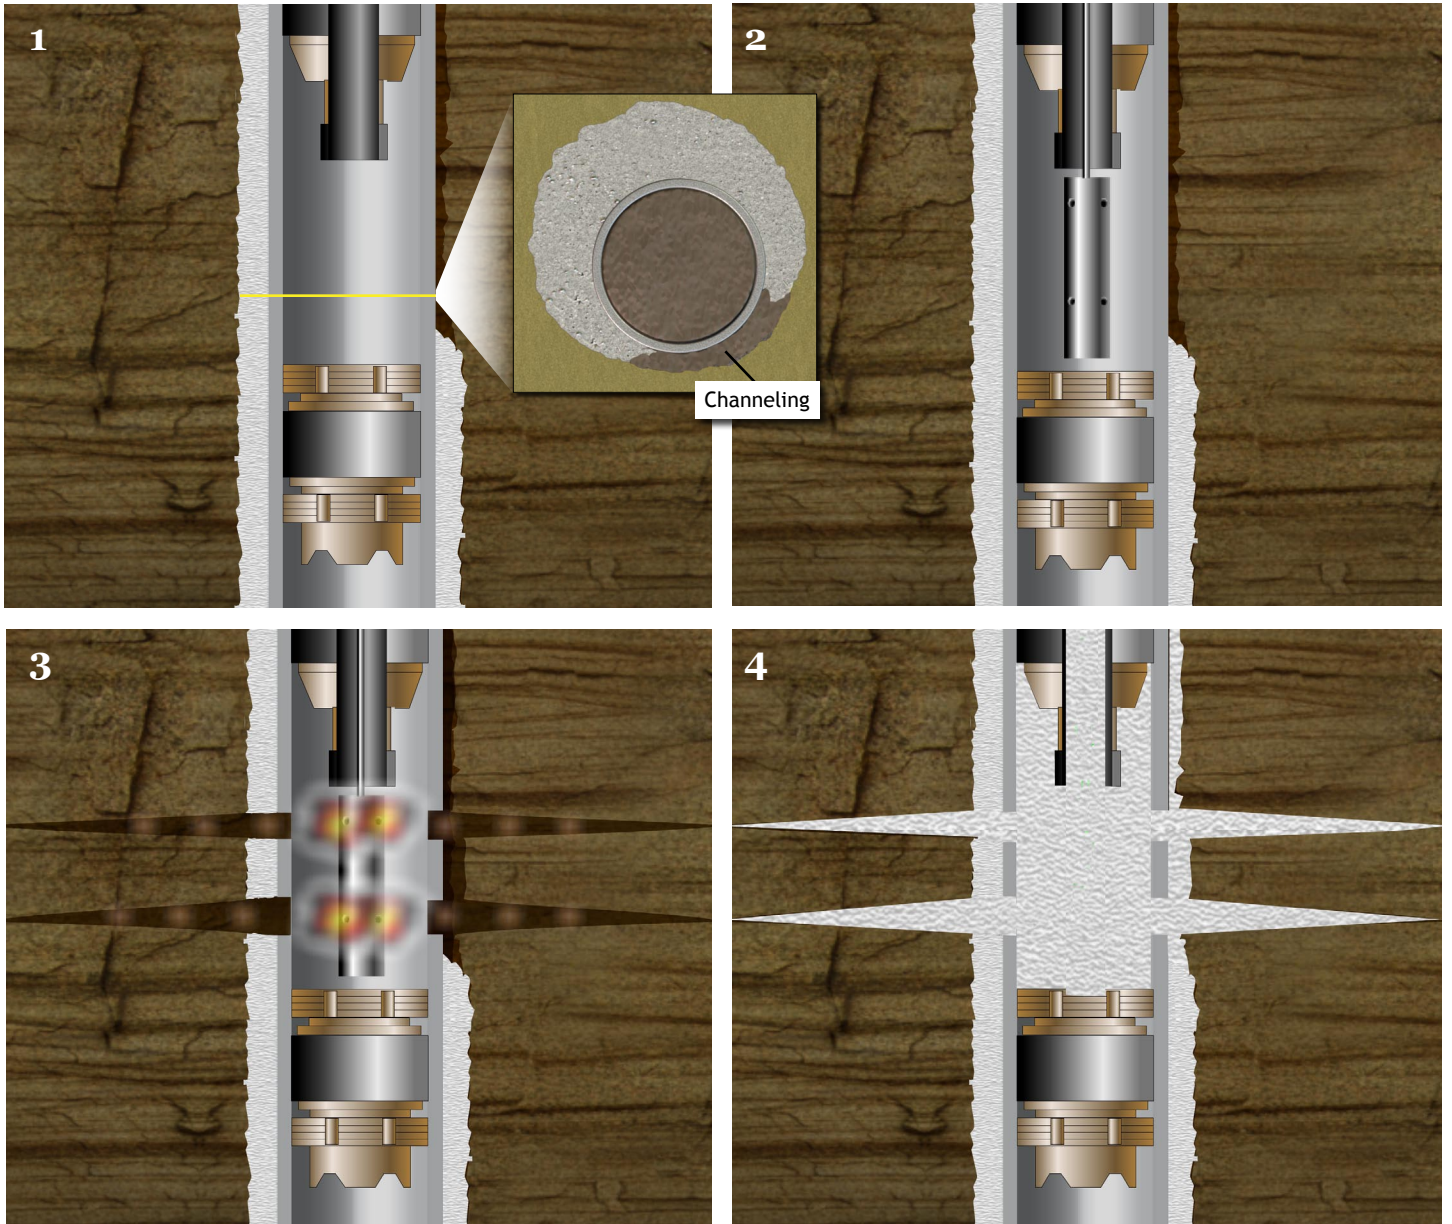
Figure 4.3.12. Remedial cementing—squeeze job.

From upper left: 1) Poor centralization has led to channeling; 2) a bridge plug is placed below the remediation area, and a packer is positioned above; 3) a perforation gun is lowered and fires shells through the casing and into the formation; 4) cement is pumped into the area, forced through the perforations, and into the formation, creating a seal.

executed squeeze job, the remedial cement then flows into the annular spaces where the primary cement has failed, filling in any channels and isolating zones as necessary.

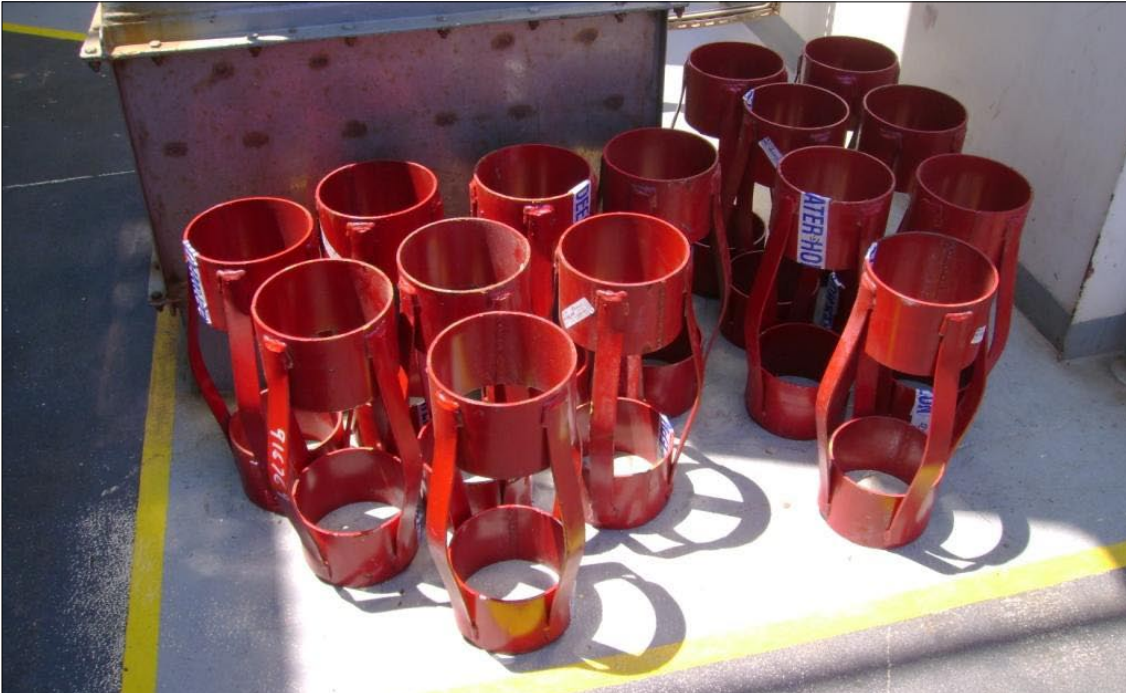
Figure 4.3.15. Centralizers delivered to the *Deepwater Horizon* on April 16, 2010.

Morel was still visiting the rig at the time the helicopter landed. He examined the centralizers when they arrived. Like the other BP engineers, he had expected that the centralizers would have integrated stop collars. He now recognized that this was not the case.¹¹¹ Morel called Guide and told him that these were not the “one-piece” centralizers that he was expecting. Guide agreed they were not what he had planned on using either.¹¹² Morel took digital pictures of the centralizers and emailed them to Guide, telling him that “the centralizers do not have the stop [collars] on them.”¹¹³ However, Morel also told Guide that the centralizers could still be used because the boat carrying the collars would arrive in “plenty of time before needing them.”¹¹⁴

I just found out the stop collars are not part of the centralizer as you stated. Also it will take 10 hrs to install them. We are adding 45 pieces that can come off as a last minute addition. I do not like this and as David approved in my absence I did not question but now I very concerned about using them

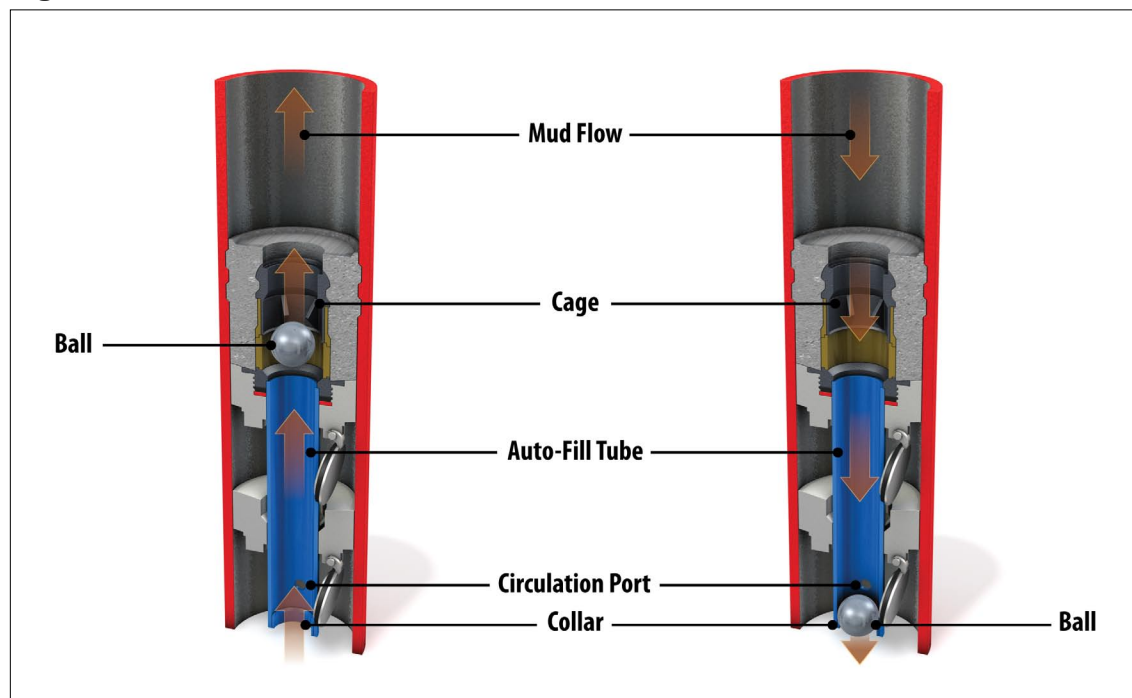
Figure 4.3.17. Auto-fill float collar.

The float collar's auto-fill tube contains a 2-inch weighted ball, which is free to move within the tube but not out of it. At the top of the float assembly is a plastic cage that prevents the ball from escaping but allows mud to flow through. At the bottom is a phenolic resin collar that is less than 2 inches in diameter, which also allows mud, but not the ball, to flow through. When casing is being run, mud flowing up through the tube pushes the ball against the inside of the cage. When the casing lands, the ball falls to and plugs the bottom of the tube, leaving two small holes on the side of the tube as the only path through the tube for mud circulated down through the well.¹⁴⁵

Flow while casing is being lowered (left) and flow during conversion (right).

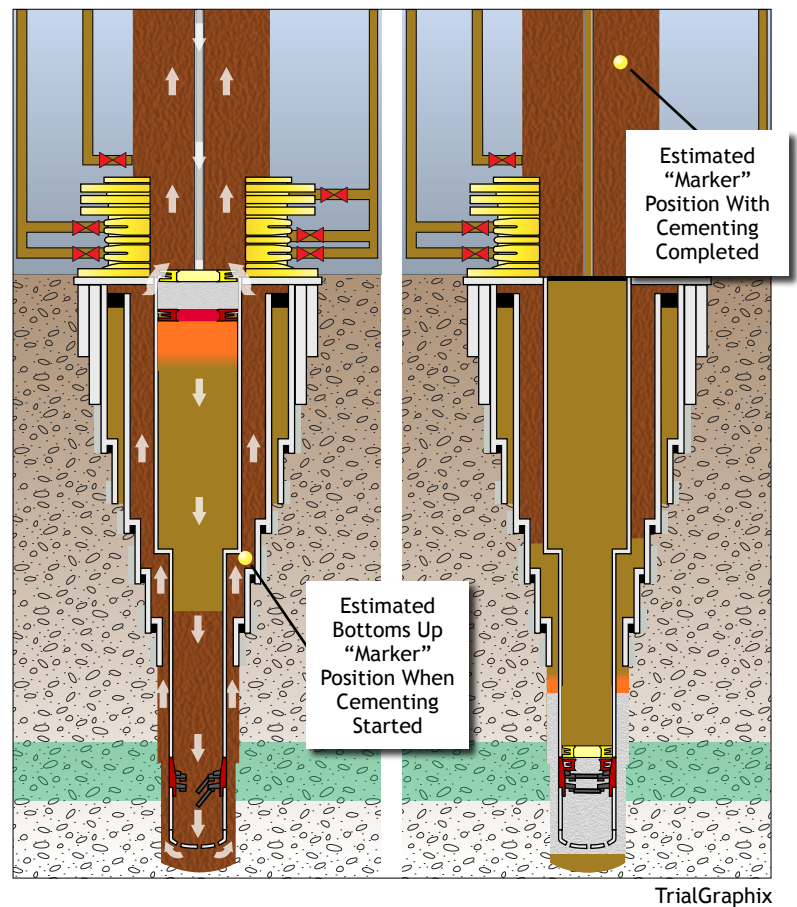
Figure 4.3.18. BP’s pre-cementing mud circulation.

At approximately 4:18 p.m. on April 19, the rig crew re-established mud circulation after running the long string.¹⁹⁹ The rig crew then circulated a total of approximately 350 barrels of mud at rates up to 4 bpm before beginning the cementing process.²⁰⁰ This figure exceeds the 261 bbl called for in the April 18 Halliburton cement job procedure²⁰¹ but is significantly lower than the 2,760 bbl required for a full bottoms up.²⁰²

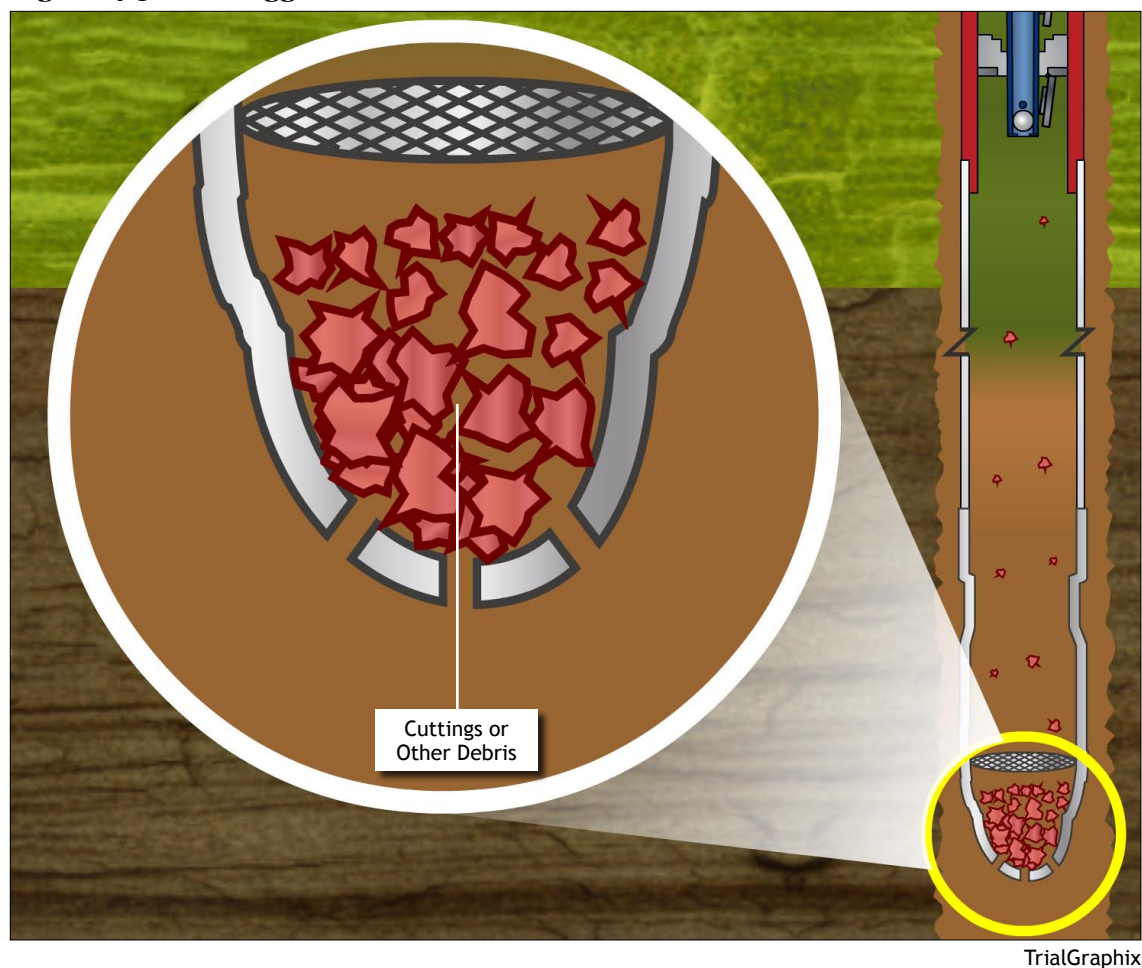
Figure 4.3.20. Clogged reamer shoe.

bottom of the reamer shoe.³⁰⁵ Debris and/or cuttings may have plugged these holes during the course of casing installation as shown in Figure 4.3.20. This could explain why the rig crew was unable initially to establish mud circulation after landing the production casing. It could also explain why the pressure dropped suddenly from 3,142 psi—that pressure may have been sufficient to clear a clog in the reamer shoe to allow mud to flow again.

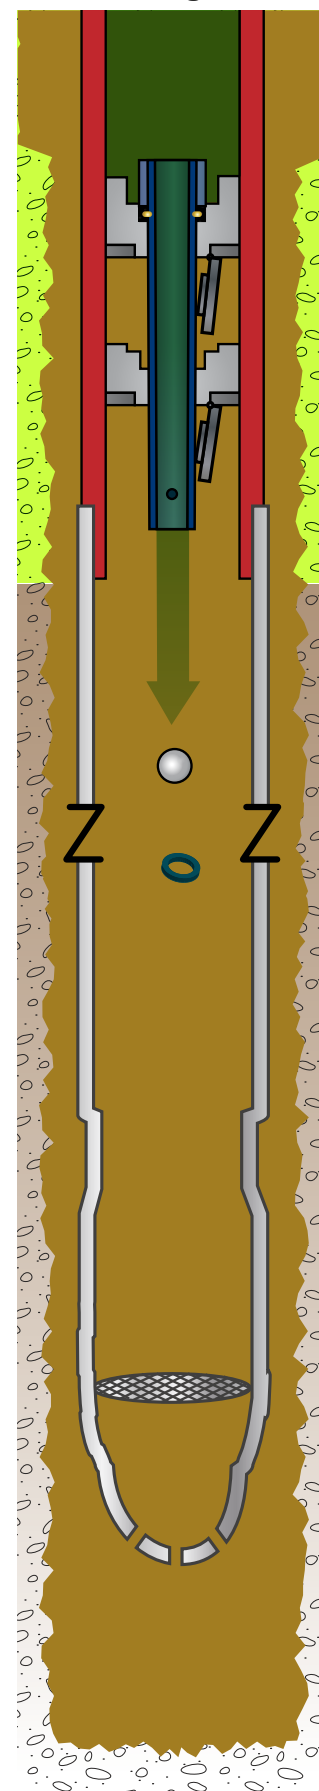
Figure 4.3.21. Ball forced through tube.

A second possibility, shown in Figure 4.3.21, is that the sudden pressure drop may have been caused when pump pressure forced the ball inside the auto-fill tube through the end of the auto-fill tube. The collar that would normally have retained the ball within the auto-fill tube was held in place with brass pins. It is possible those pins and the collar failed, allowing the ball to pass through.³⁰⁹ This would have left the auto-fill tube in place between the float valves and created a path for flow in either direction.

If the ports in the bottom of the auto-fill tube were clogged, the rig pumps may have placed enough force on the collar to shear the brass pins instead of the pins holding the auto-fill tube in place. Clawson informed Morel on April 19 that it would only take 1,300 psi of pressure to force the ball through the collar without converting the float valves.³¹⁰ It is not apparent whether Morel considered or informed others of this possibility.³¹¹

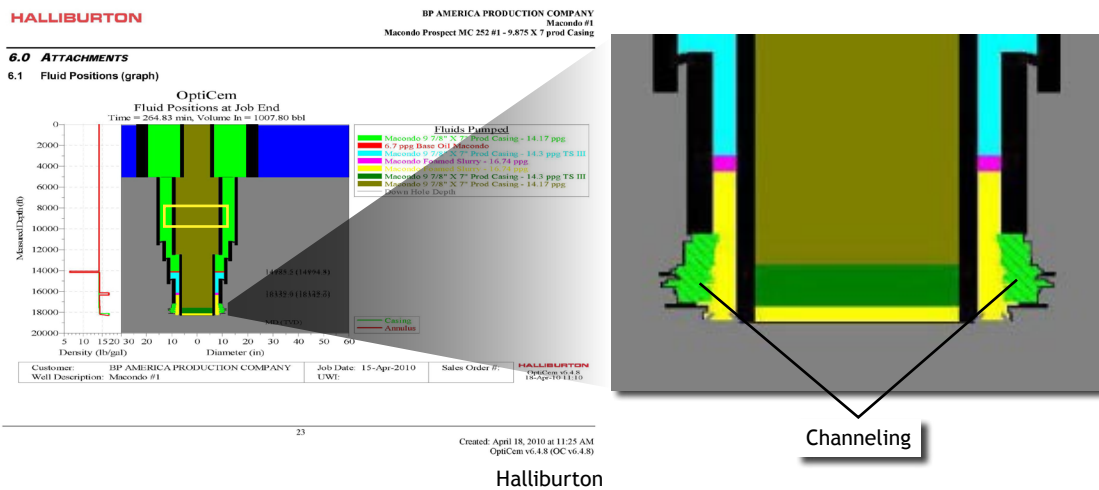
Figure 4.3.22. Page 23 of Halliburton's April 18, 2010 OptiCem™ report.

Halliburton personnel explained the green areas as predicted channeling.

the report. Instead, the reports presented information in an obscure and unnecessarily technical manner. (For instance, as shown in Figure 4.3.22, the reports present channeling predictions only as unexplained jagged lines in a well diagram).³⁶⁷ As a result, BP engineers reviewed the predictions in a cursory fashion, if at all.³⁶⁸
