INTERPRETATION ON SOME OF PRINCIPAL STRUCTURAL DAMAGE DURING THE 1995 KOBE EARTHQUAKE

SUMMARY

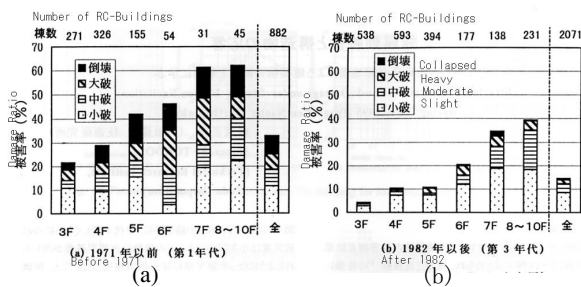
Reinforced concrete buildings also suffered various kinds of structural damage. As shown in Fig.1, the discussion was made using statistical analyses to point out the fact that most of damaged buildings were constructed following to the older building code, and that others based on the 1981 newer code did not have serious damage. Then there is no reason to improve the existing building code. The only problem is how to maintain such remaining buildings with the older code.

Fig.1 Statistics of damaged RC-buildings. (a) Old structures before 1971, and (b) Recent structures after 1982. (after Tohdo in AIJ, 1998)

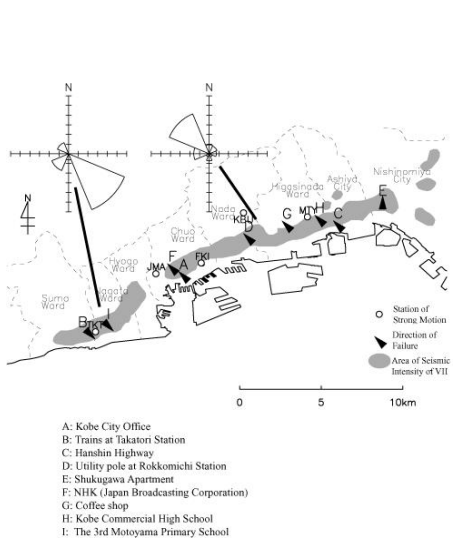
While we walked around Kobe and Hanshin districts many times, we noticed that the direction of failures for individual collapsed buildings, other structures including Hanshin Highways and overturned trains, looked very systematic as showing Fig.7. The direction was always towards the normal axis against the fault, to the northwest in the eastern side from Hyogo ward of Kobe city, on the contrary to the southeast in the western side. There was no exception in this tendency as if there were a node in Hyogo ward. Such direction of failures can be

Fig.7 Direction of collapsed buildings and structures

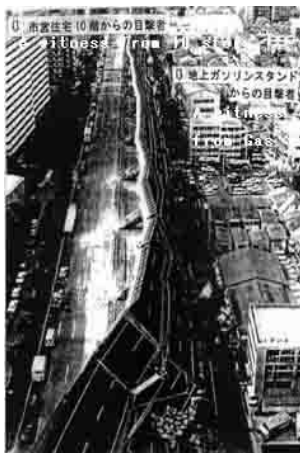
After all we started the survey in 2001, after 6 years from the earthquake. We found two persons who were watching the failure by checking reliabilities very carefully. One person was working in front of gas station located just on the northern side from the highway (Photo.1). According to his explanation in our interview, he fell and landed during the strong shaking, and was watching the behavior of the highway. At that time the highway was shaking without falling down. After a couple of minutes from the strong shaking, the highway started falling down against his side (north) from the west toward the east grading up the speed. He also found an empty truck had landed from the highway to the ground level and run away.

Photo.1 Overturning failure of Hanshin Highway and the location of watchers

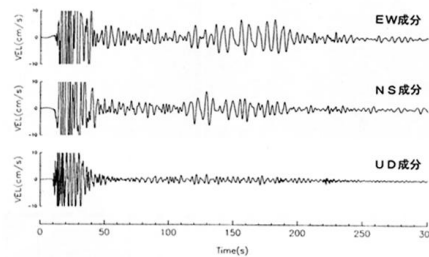
Therefore we tried to find the possibility meeting with such experiences. We checked the nearest observed strong motion as shown in Fig.10 very carefully. There were no effective aftershocks in the record, but we found a later phase with about 6 seconds in period that was very clear in velocity seismogram. We could assume a possibility that the later phase might be Love wave as a result of two-way reflection across the Osaka bay like Fig.11. An examination has been tried with 2-dimensional finite differential method as shown in Fig.12 (after Kurita et al., 2004).

Fig.10 The nearest strong motion in velocity. A later phase appeared after two minutes with 6 seconds in period.

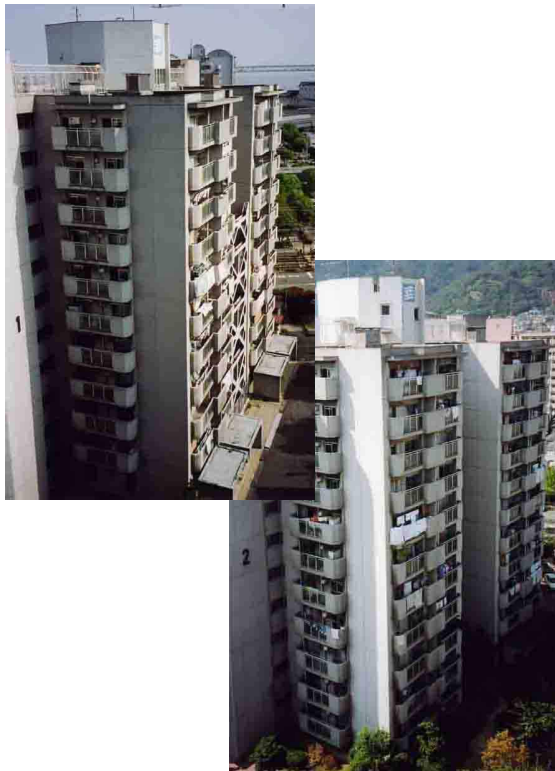
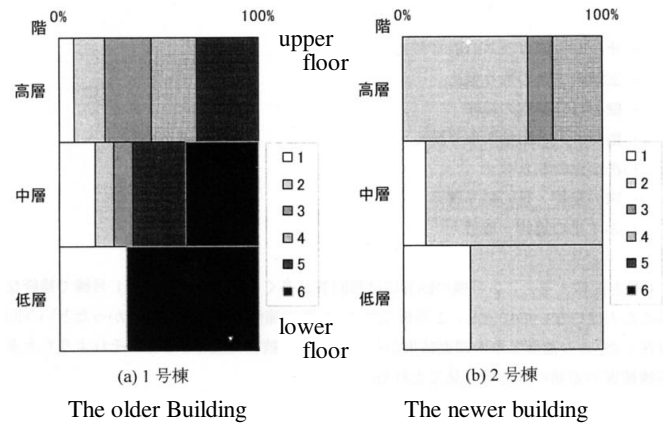
According to the results of our questionnaire to living people, the older building suffered much heavier damage than the newer one. For example, the people in the older building felt much harder shaking, suffered heavier damage on furniture, heavier cracks including seismic walls and around entrance steel doors. Therefore they could not open the doors for evacuation. Such people had to stay much longer duration in other evacuation places because it looked very dangerous to live there (Fig.14). The local government repaired these buildings without moving the living people using additional seismic walls on the ground level. The steel frames mentioned above were put only for the older building, because the government judged the damage of the older one looked much harder although they were not sure such countermeasures were good enough or not.

Then we made a comparison of these two buildings using measured ambient motions on the top of both buildings. Some of measured dataset was quite interesting to explain their dynamic behaviors. The natural period of longitudinal direction was about 0.60s for both buildings. It meant that the steel frames of the older building worked well to have similar characteristics with the newer one, and such natural period looked quite reasonable for general RC-building with 11 floors. In the rectangular direction, the older building showed much longer natural period as 0.54s, while the newer one showed 0.48s. It was also reasonable that the older building might be softer than the newer one, maybe due to the different building code. After the enforcement with steel frames for the older building, it became much easier to have torsions. As we have just examined such features with only ambient motions, we recommended the local governors to make more careful surveys for both buildings. They should have made such surveys just after the earthquake or at least before the repairs.

2) Significant later phase could be seen in the seismic record obtained in the coastal region of the Osaka basin. This later phase with long period trigger the overturning failure of Hanshin highway buildings. Photo.2 RC-building built with the older code Fig.14 One of questionnaire results showing different degree of damage distribution between the older (left) and the newer (right) buildings. Question was how long time you had to evacuate from your home.

3) Two residential buildings, one was constructed with the older code and the other one was constructed with the newer code. The former or the latter did not suffered so much. 1: not evacuated 2: within one week 3: within two weeks 4: within one month 5: within two months 6: more than two months Photo.3 Similar building built with the newer code
