Chapter 4.3 | Cement

Well Cementing

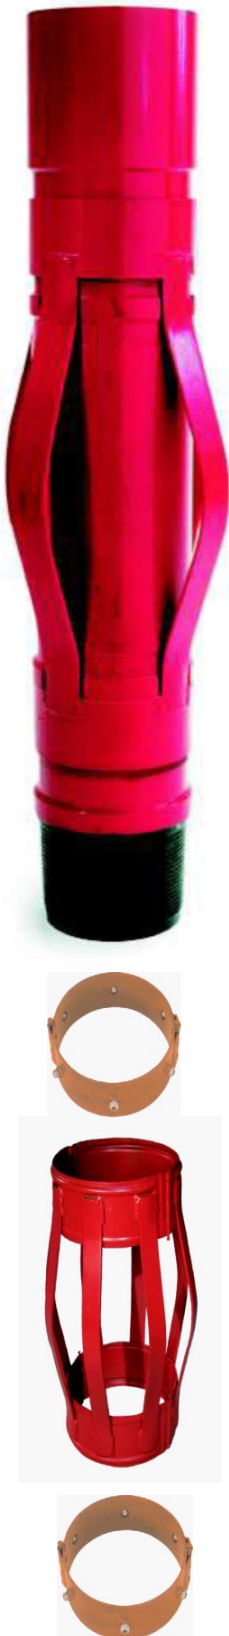
Figure 4.3.13.
Centralizer sub (top)
and slip-on centralizer
with stop collars
(bottom).

I just found out the stop collars are not part of the centralizer as you stated. Also it will take 10 hrs to install them. We are adding 45 pieces that can come off as a last minute addition. I do not like this and as David approved in my absence I did not question but now I very concerned about using them

lowered all the way to the bottom of the wellbore—a serious problem that would take significant time to fix.¹¹⁶ Guide also noted that installing this type of centralizer would alone take 10 hours.¹¹⁷ In a phone call with Walz, Guide weighed the risks of losses that fewer centralizers presented against the risk of a “last minute” addition of unfamiliar centralizers. There was no discussion at that point of stopping the job in order to procure the “correct” style of centralizers.¹¹⁸ Instead, Guide told Walz and Sims he was reverting to the original plan. Sims agreed. Walz also accepted the reversal, saying, “I agree. This is not what I was envisioning,” and apologized to the rest of the drilling team for the “miss-step” of ordering centralizers.¹¹⁹

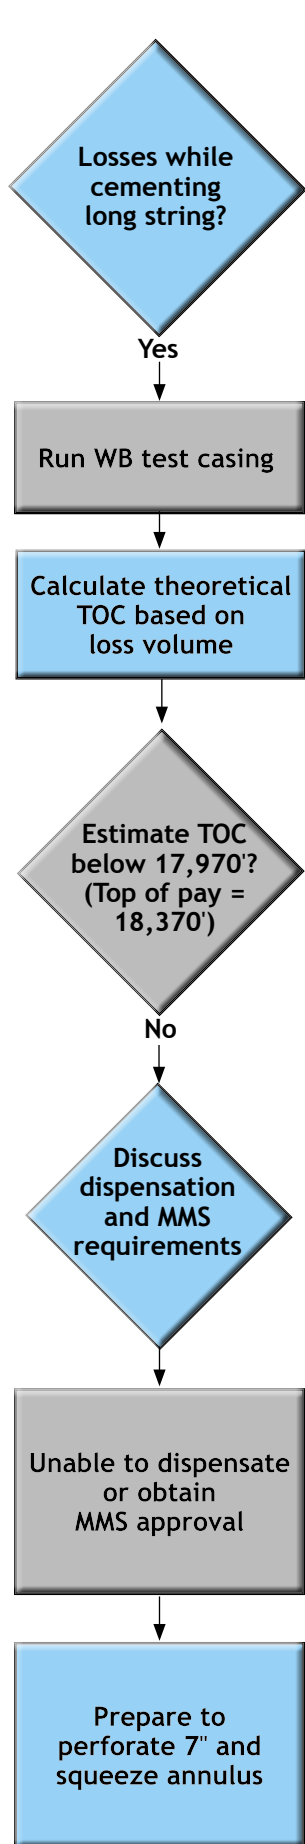
Figure 4.3.19. Decision tree.

reported losses while pumping the cement job, the decision tree stated that BP engineers would “Calculate theoretical [top of cement] based on loss volume.” If that calculation estimated that TOC was *below* 17,970 feet that would mean that there was less than 100 feet of cement above the top of the pay zone—400 feet less than MMS requires.²⁴⁷ In that situation, the decision tree required a “log to confirm” the TOC.

If the theoretical calculation predicted that TOC was *above* 17,970 feet, the decision tree stated that the Macondo team would discuss MMS requirements and consider seeking a dispensation. If unable to get dispensation or “obtain MMS approval,” then BP would “perforate” the casing and “squeeze” the annulus to remediate the cement job. An operator would not normally run a cement evaluation log and plan to remediate cement before temporary abandonment operations; the Macondo team’s explicit discussion of these contingencies illustrates how concerned they were about the possibility of cement losses.²⁴⁸
