INTERPRETATION ON SOME OF PRINCIPAL STRUCTURAL DAMAGE DURING THE 1995 KOBE EARTHQUAKE

SUMMARY

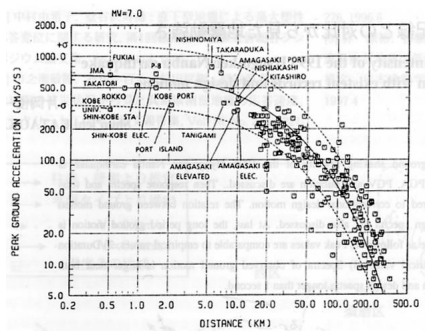
understanding appeared very soon that the attenuation characteristics looked quite reasonable compared with past experiences like Fig.3. Inversion analyses with neighboring strong motions have been examined by many researchers to show the source mechanism in detail as shown in Fig.4. Some geologist doubted the existence of submerged fault just beneath the heavily damaged belt zone, but the general understanding after a while was to imagine two-dimensional or three-dimensional underground topography like Fig.5. Measured microtremors across this heavily damaged belt zone also showed very systematic change of characteristics as shown in Fig.6.

Fig.3 Attenuation of PGA during the 1995 Kobe earthquake (after Kataoka in AIJ, 1997)

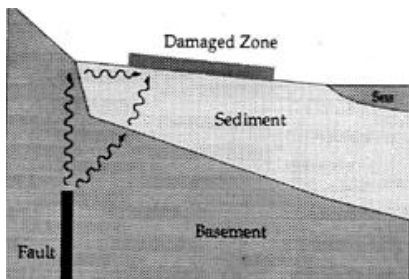
Fig.5 Concept to explain damaged belt zone with the underground topography (after Koketsu et al. in AIJ, 1996)

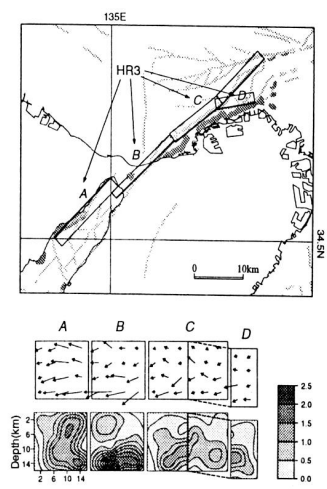
Fig.4 Source model and slip distribution for the 1995 Kobe earthquake (after Koketsu et al. in AIJ, 1997)

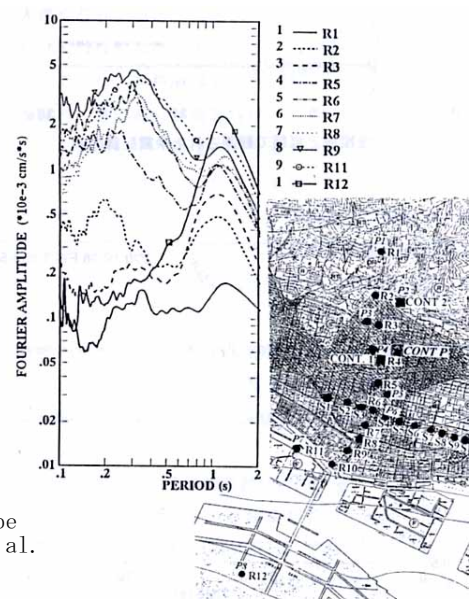
Fig.6 Measured microtremors across heavily damaged belt zone (after Seo et al. in AIJ, 1995)

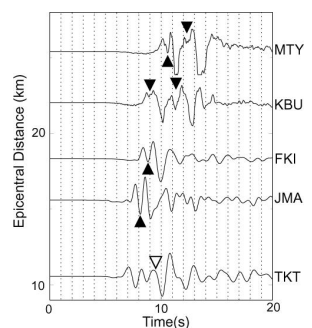
Fig.8 Velocity strong motions with effective phases contributed to the failure of buildings and structures

explained using neighboring strong motions like Fig.8 by assuming 1DOF response analyses.

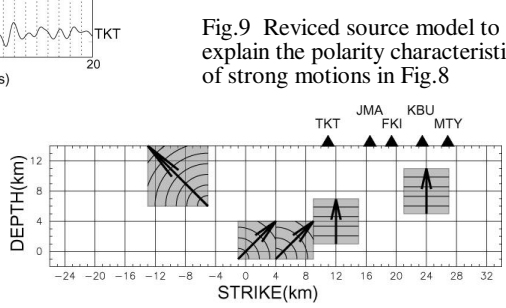
Fig.9 Revised source model to explain the polarity characteristics of strong motions in Fig.8

And to explain the polarity characteristics of strong motions, a source model for the 1995 seismic fault could be presented like Fig.9. The most important point is that the observed strong motion at JR-Takatori (TKT) will not accept the current rupture from the hypocenter. We need an effective asperity just beneath Hyogo ward in Kobe city to collapse structures distributed in Nagata and Takatori wards. Of course we need more careful consideration about this subject, but it is required in deed to prepare a synthetic interpretation throughout the source mechanism, underground structures, observed strong motions, and the behavior or damage of buildings and houses.

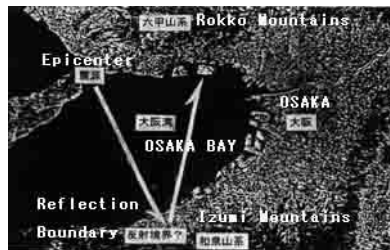
Therefore we tried to find the possibility meeting with such experiences. We checked the nearest observed strong motion as shown in Fig.10 very carefully. There were no effective aftershocks in the record, but we found a later phase with about 6 seconds in period that was very clear in velocity seismogram. We could assume a possibility that the later phase might be Love wave as a result of two-way reflection across the Osaka bay like Fig.11. An examination has been tried with 2-dimensional finite differential method as shown in Fig.12 (after Kurita et al., 2004).

Fig.11 Concept to explain a possibility of long-period later phase in Fig.10 with surface waves across the Osaka bay.

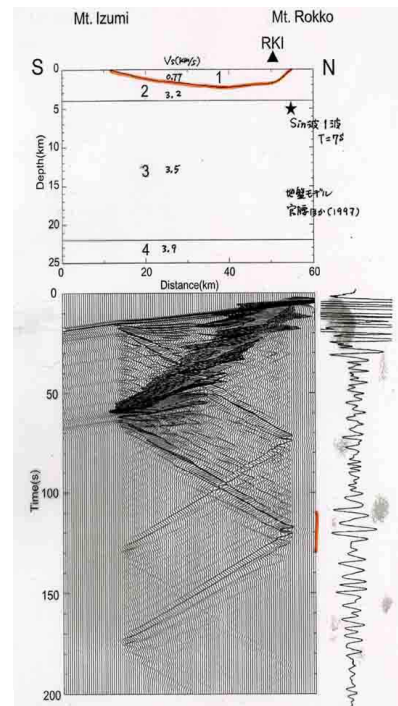
Fig.12 A trial of 2-DFDM analysis for Fig.11 by assuming basin structure.
